Noble International Ltd.

NOBLE CHARLES COPELAND HIGH POTENTIAL NEAR MISS

**Drilling Operations Incident Review
Committee (DOIRC)**

10-Nov-2008

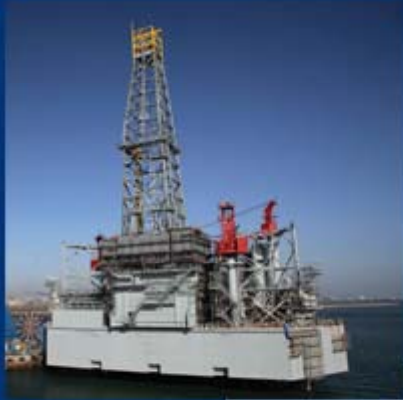
- The drill crew and deck crew were in the process of laying down 3-1/2" tubing. The tubing as prepared and bundled on the catwalk, then the tubing was bundled and placed on the cantilever pipe deck.
- When the catwalk was full of tubing that was being fed from the V-door, the Floormen would tell the Assistant Driller and the process would stop.
- When the bundle of tubing from the catwalk had been placed in the pipe rack and the catwalk was clear, the laying down of tubing from the drill floor would continue.

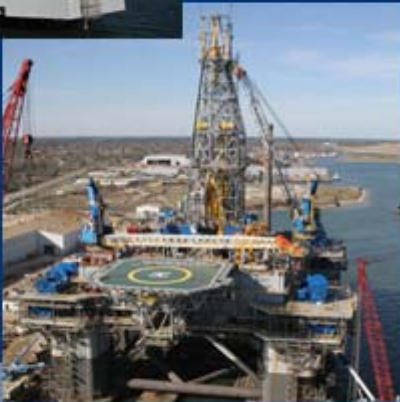
- Prior to the incident, the catwalk was full of 3-1/2" tubing. No one communicated to the Assistant Driller - who was on the brake at the time - that the catwalk was full and to stop the process.

NOTE: The AD is experienced in his position and the Driller was standing near him observing the job.

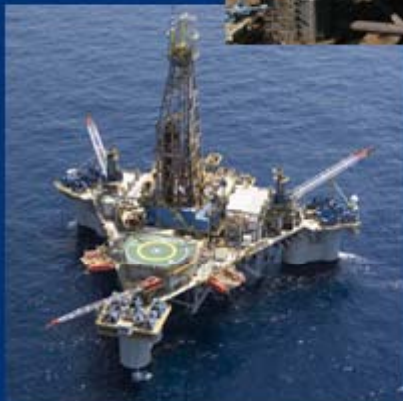
- The Floorhands had just picked up a single joint from the mouse-hole and moved the single to the edge of the V-door when they noticed the cat walk was full. The single hanging from the air hoist was then rested on the wood deck in front of the V-door ramp.
- The Assistant Driller had broken out and picked up the next single joint and was lowering it into the mouse hole, when the top drive struck the single joint that was attached to the air hoist line resting near the V-door.
- This resulted in the single joint being bent. There were no injuries.

- The pre-job planning and JSA failed to identify the hazard that could occur with a single joint hanging on the air hoist line and resting on the rig floor and the top drive in motion.
- The Supervisor did not delegate any responsibilities / instructions to the positions (i.e. air hoist operator) about who was to communicate to the person operating the top drive-Asst. Driller.
- Due to the rotation of the workers positions it was not clear to them which one was responsible to carry out the controls. No clear hand-over was conducted when rig floor personnel changed positions.

- Due to the configuration of the derrick, the air hoist line placement allows it to be in line with the side of the top drive. Normal practice for laying down 5" drill pipe would be to install a sheave under the monkey board for the tugger line to deviate it away from the top drive. This was not done for laying down the 3-1/2" tubing.
- The Driller, who just came back from a break was at the Driller's console with the Assistant Driller and both of them were focused on the tubing joint going in the mouse-hole. Neither realized the hazard of the single joint of tubing that was standing near the V-door. They thought the Floorman was pushing it out the V-door.

- Develop a new JSA with all the specific steps and controls required to:
 - a) - lay down DP/ tubing-
 - b) include the hazards involved with tubing /DP hanging on a tugger line
 - c)- TDS coming in contact
 - d) - add tugger line deviation sheave under monkey board as part of the controls.
- Ensure when a JSA is reviewed during the pre-job meeting, the Supervisor delegates responsibilities for the controls indicated on the JSA. The Supervisor shall ensure each member understands his responsibility, and indicate this on the JSA with each person signing their own name.
