Noble Corporation

Noble David Tinsley

**Medical Treatment Case
01-Feb-2009**

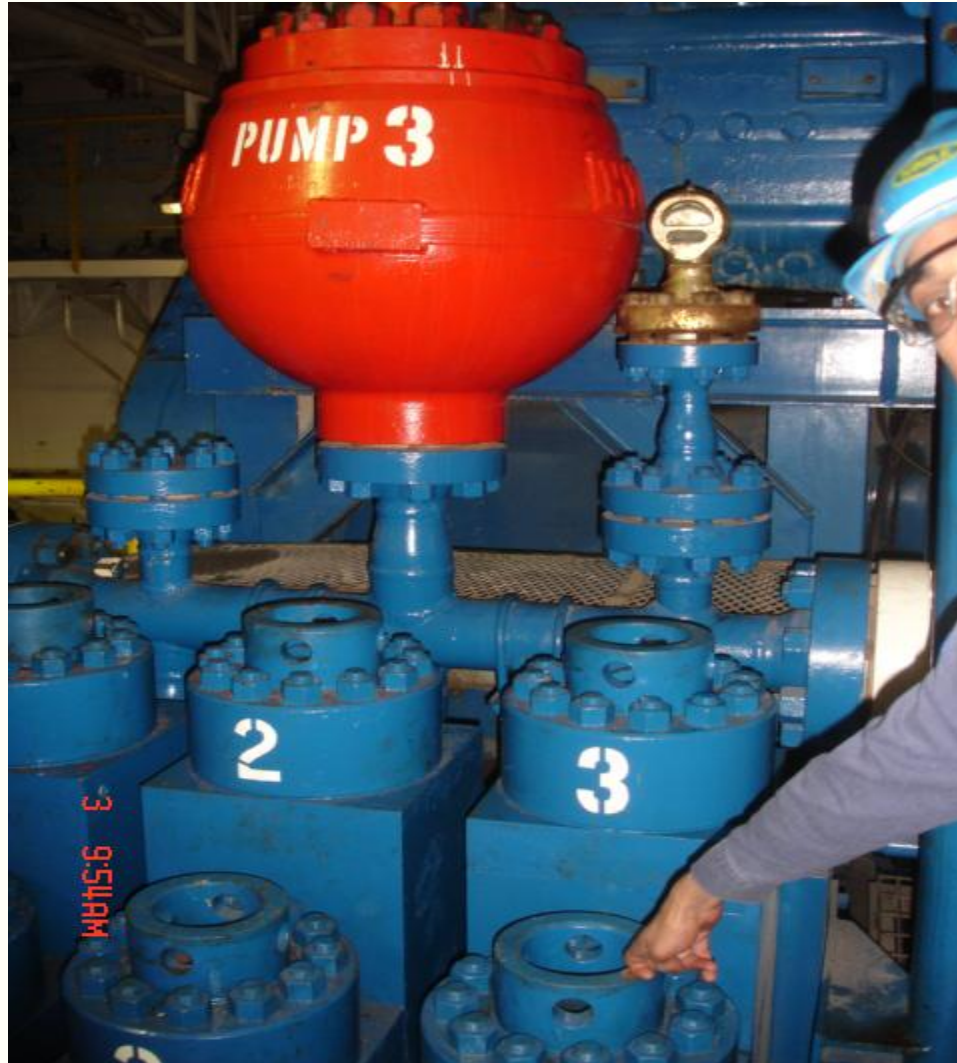
Work Area

- 1- Failure to communicate – the hazard of unsafe body positioning and the proposed corrective action of erecting a work platform was not communicated to the oncoming crew.**
- 2- Failure to perform a pre-job inspection to determine additional hazards. Supervisory and crew member perception was that we always did it that way. This was an accepted rig practice.**
- 3- Improper body position for the task at hand due to lack of proper working platform.**

- 1- When stopping a job for an unsafe condition that cannot be immediately be corrected, the Rig Manager will be notified immediately. The area will be protected with a barrier and signs will be placed stating “No work will proceed in this area until approved by the Rig Manager”. Communicate this to all crew members.
- 2- A pre-job hazard hunt shall be conducted for all jobs.
- 3- Develop a pre-job hazard hunt checklist, that includes the potential release of 8 forms of energy.
- 4- Revise JSA's for each job required to include step number 1 on the JSA being "Conduct a pre-job hazard hunt."
