# Al Doha Fatality Incident

Date of Incident: 09-January-2010

Rig/ Location: Al Doha

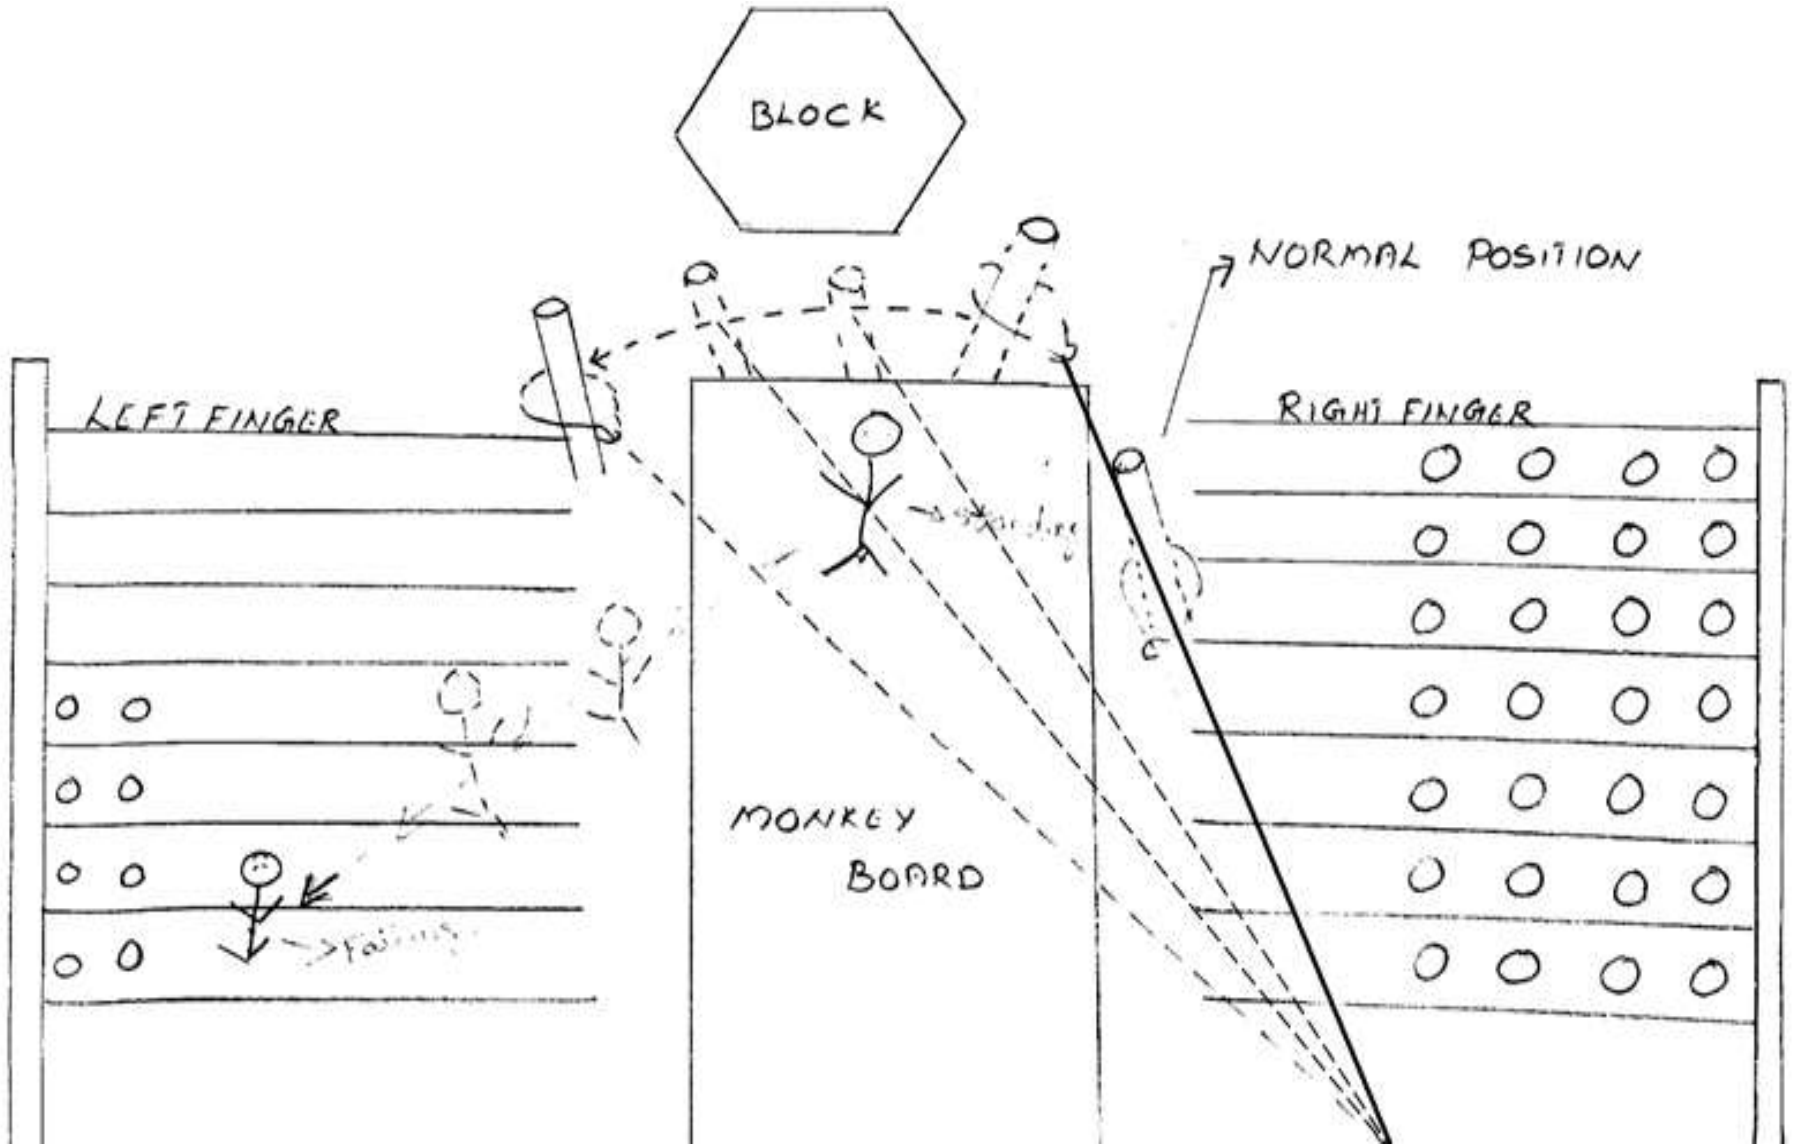
# Schematic sequence of Incident

After unlatching the first stand of DP from the elevator and pulling with remote controlled electric winch, driller started to lower top drive system. There was a sudden slack of the winch wire allowing the DP to move back into the path of the descending Top Drive System and made contact with it. Energy was transferred causing the DP to deflect which created tension on the winch wire. IP was hit by either the pipe and the winch wire or only the wire.

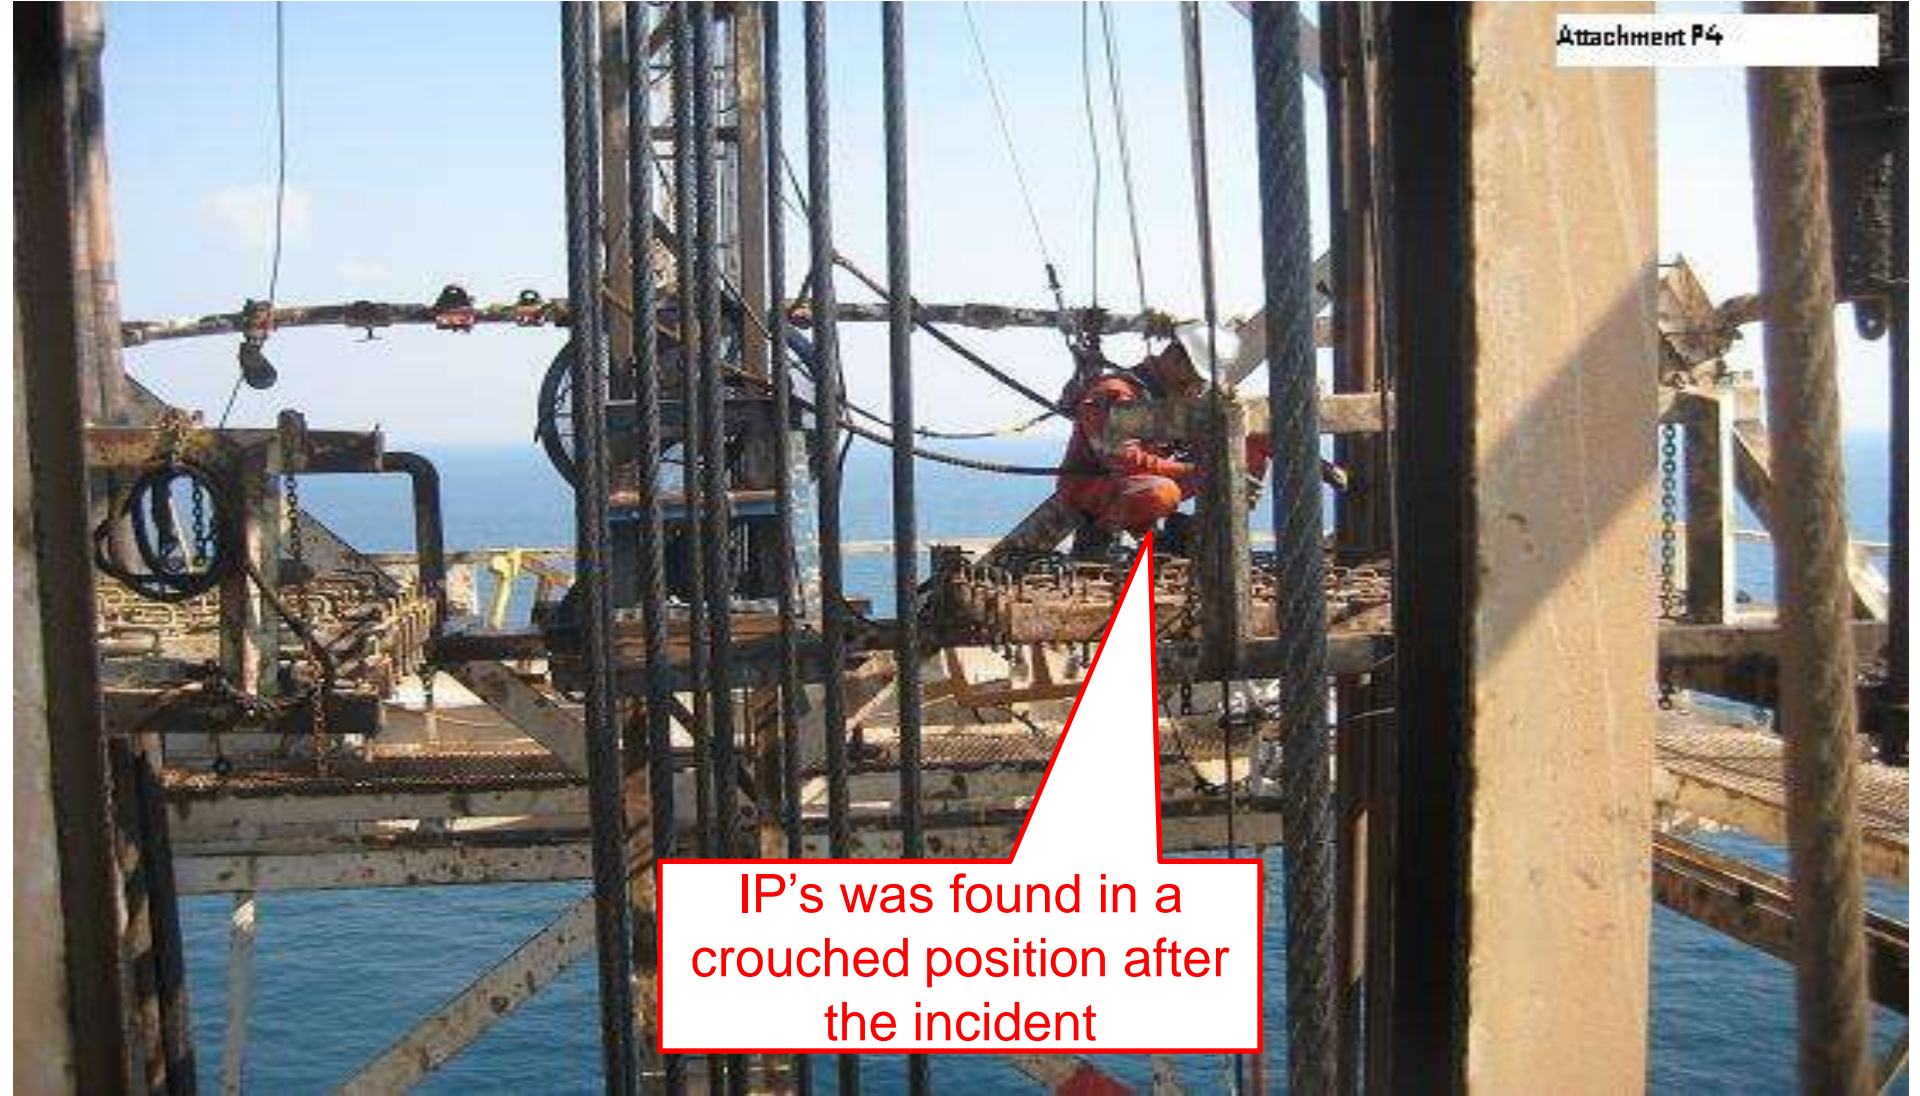
Attachment P4

IP's was found in a crouched position after the incident

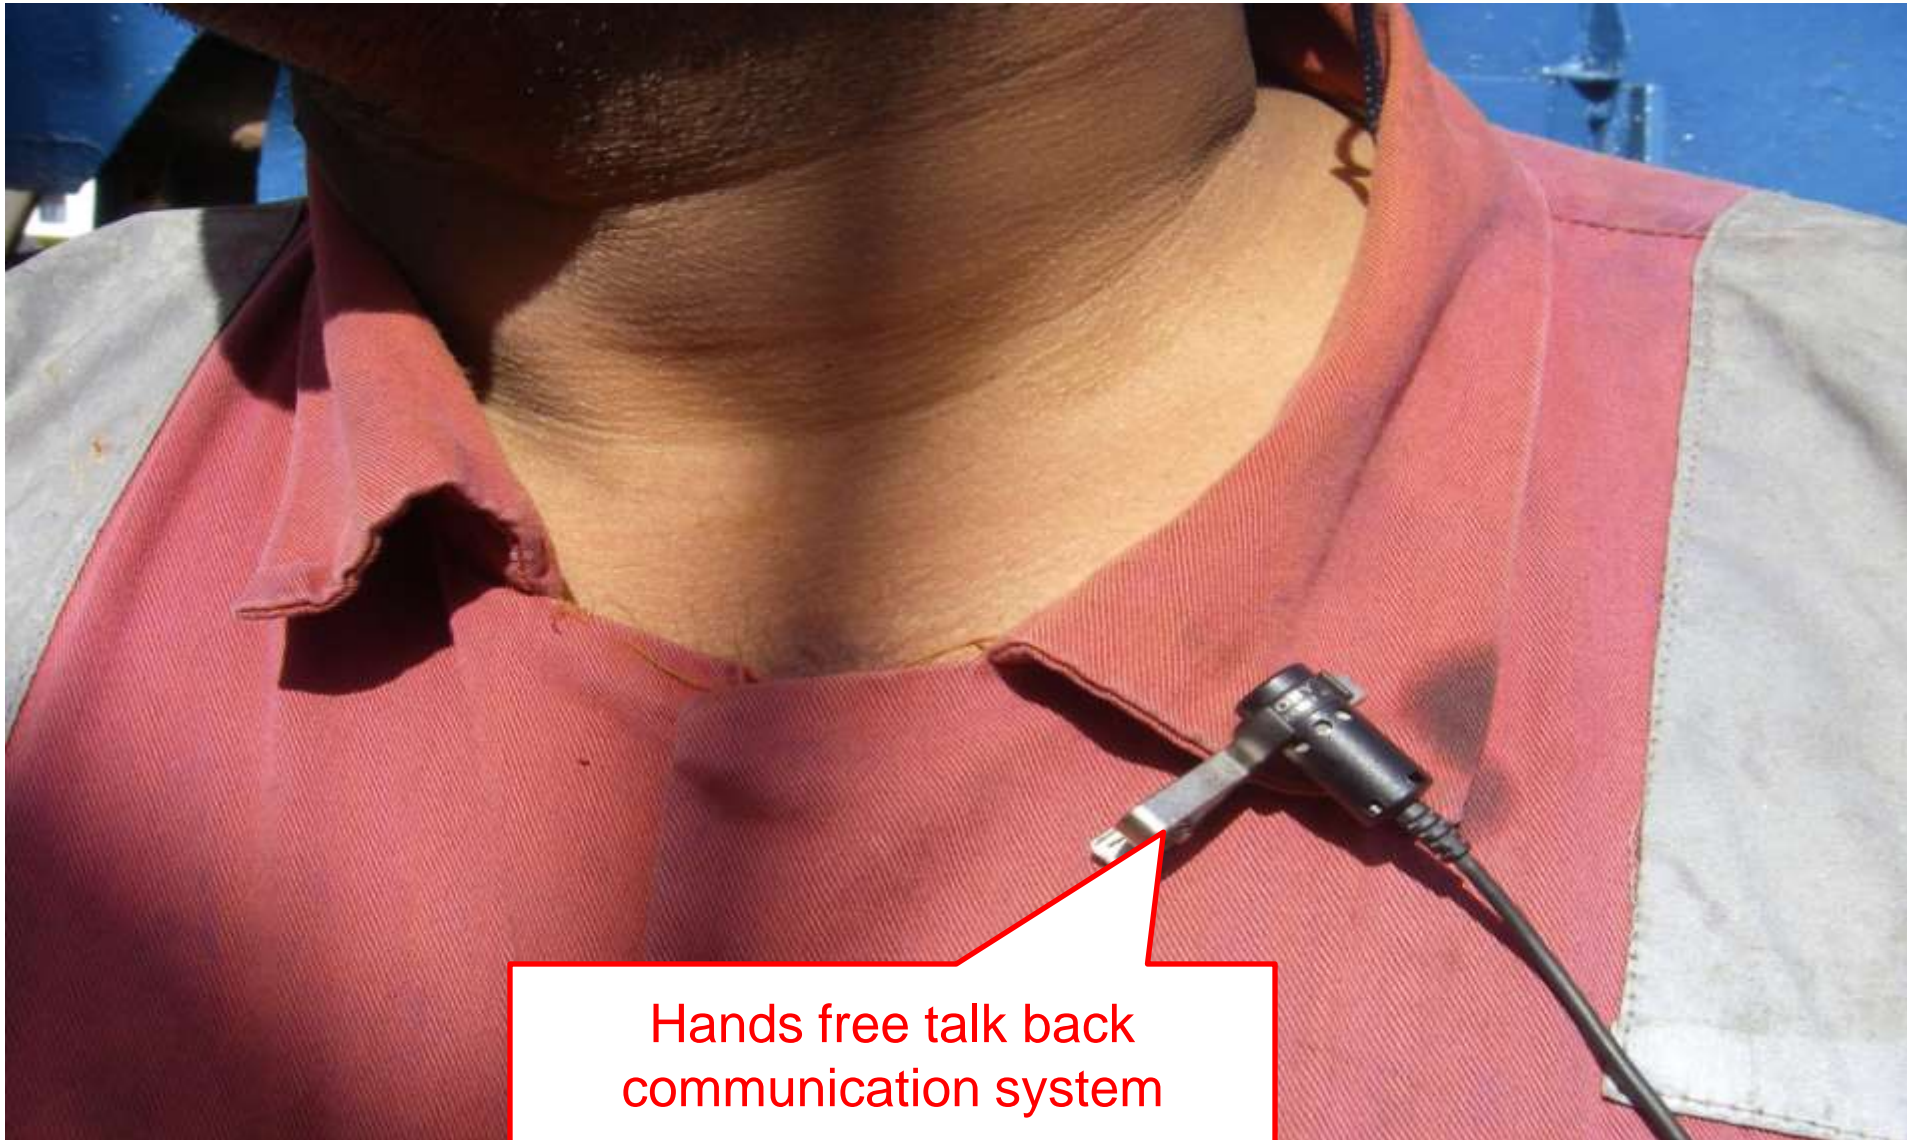
Hands free talk back  
communication system

- Drillers and derrickmen were instructed to ensure two way communication at all time and to include communication procedures in toolbox talks.
- Standing instructions were issued to rig medics to immediately activate medivac for any impact on head, chest or abdomen in addition to other emergency needs.
