# TapRoot Investigation

**Finger injuries of 3<sup>rd</sup> Engineer and  
Discharge of Product to Machinery Space  
(24<sup>th</sup> December 2009)**

***SEACOR JEFFERSON***

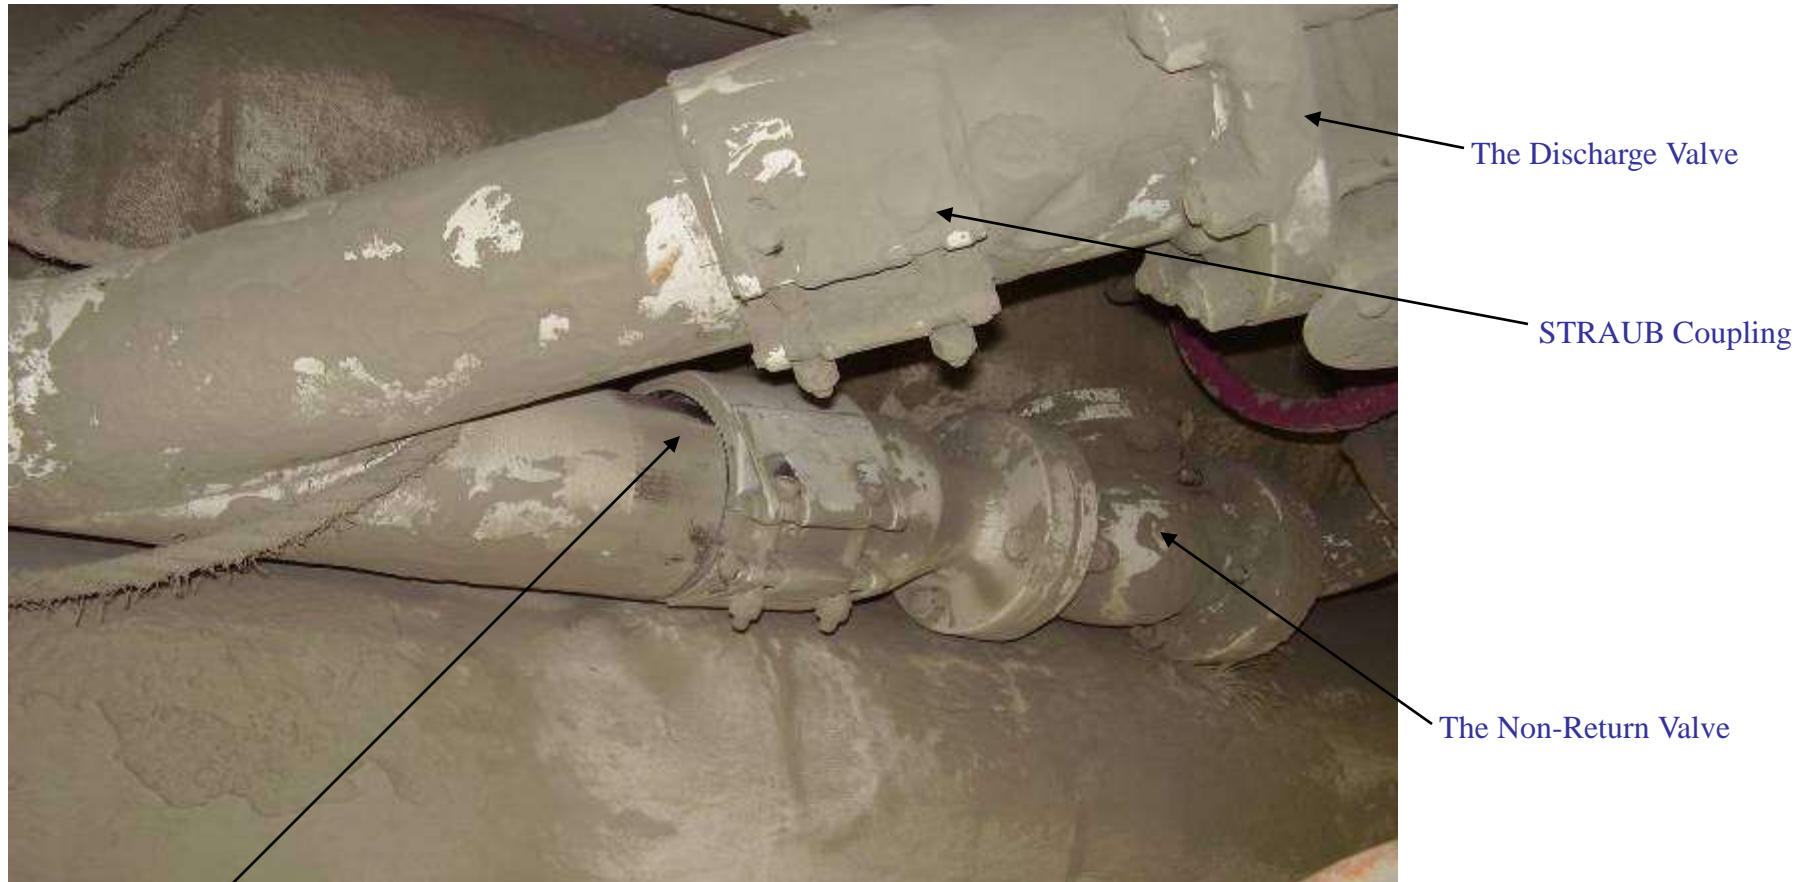
- The 3<sup>rd</sup> Engineer removed his gloves and used his bare hand to verify leaks.
- At this time the pipe ruptured around the clamp coupling causing the 3<sup>rd</sup> Engineer to sustain deep lacerations to two fingers on the left hand.

**The STRAUB-GRIP-L Coupling can clearly be seen to have moved along the piping. Visible are the scrapes of the serrated teeth and the area where the air and product under pressure to 70psi escaped.**

- **All other vessels with STRAUB-GRIP-L Couplings within RasGas fleet to be requested to check torque for compliance with manufacturers instruction.**
- **All STRAUB-GRIP-L Couplings on Seacor Jefferson to be changed out with new.**
- **Emergency escape from Machinery Space / Engine Room drills to be held on all RasGas chartered vessels. These should be documented and submitted to RasGas with any problems highlighted.**
- **RasGas QA representatives will perform Quality and Safety Audits on all RasGas chartered vessels through 2010 and will continue to ensure each vessel is audited at least once per year. This will include bulk pumping systems. It is anticipated Seacor Jefferson will be audited by mid-January**

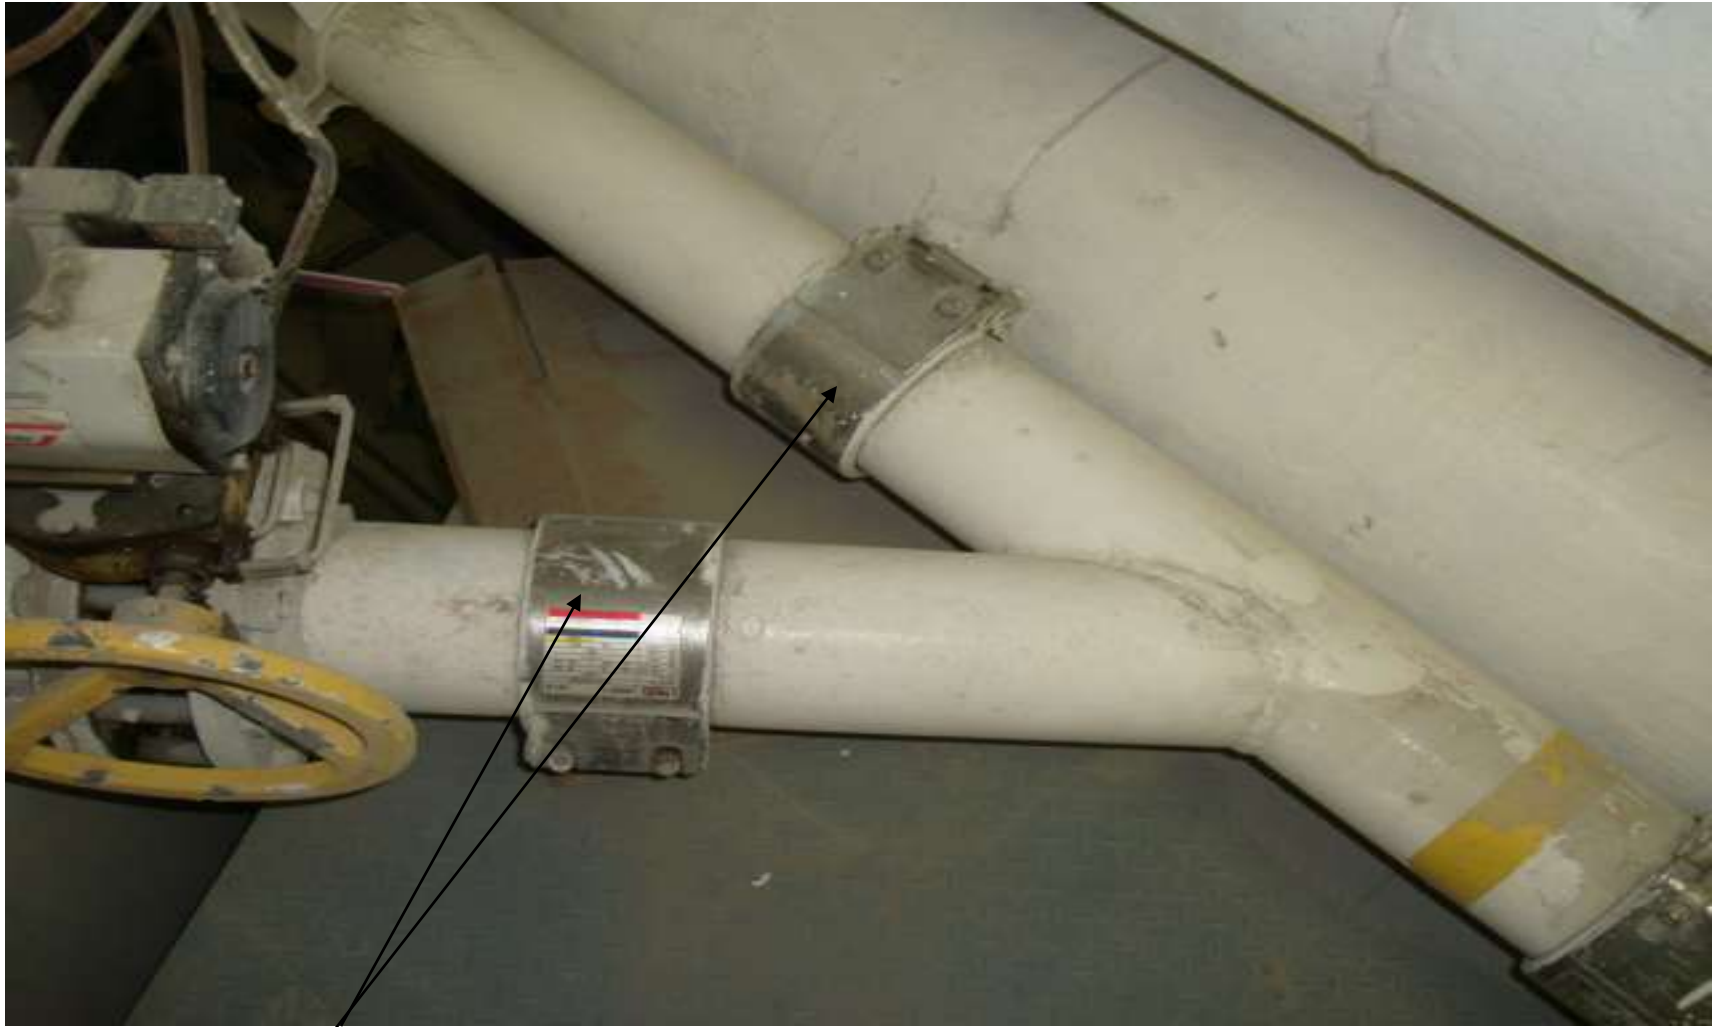
**The same clamp coupling arrangement in place at another location on the bulk discharge system**

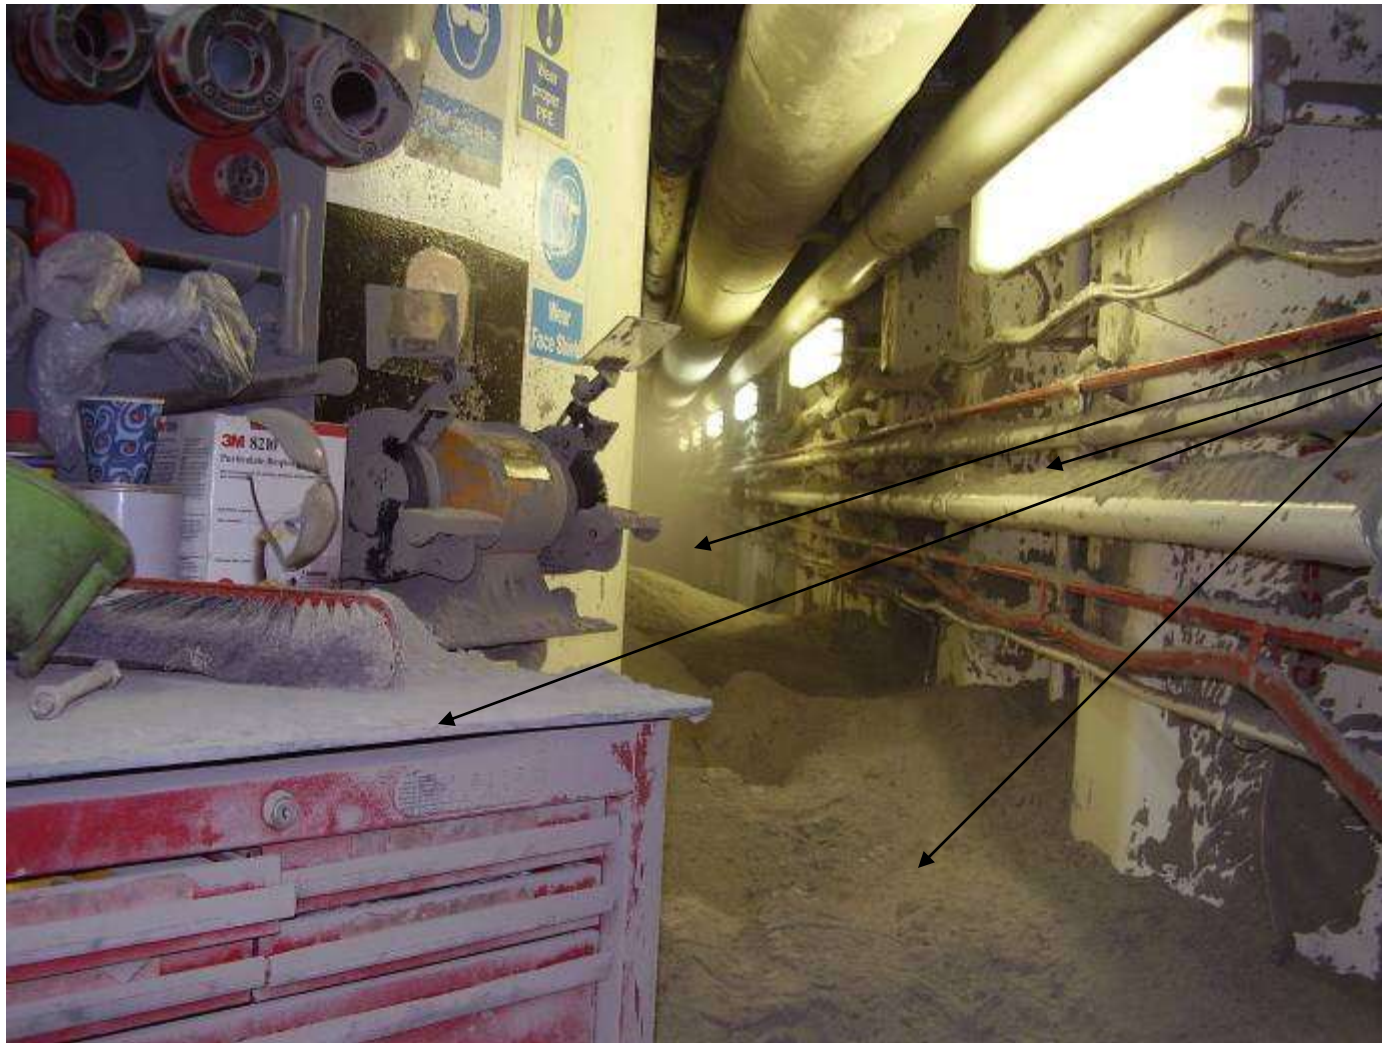
The resultant Lite-Crete spill resembled a snow drift and covered much of the machinery space, reaching a depth of around 3-4ft at the rupture point.

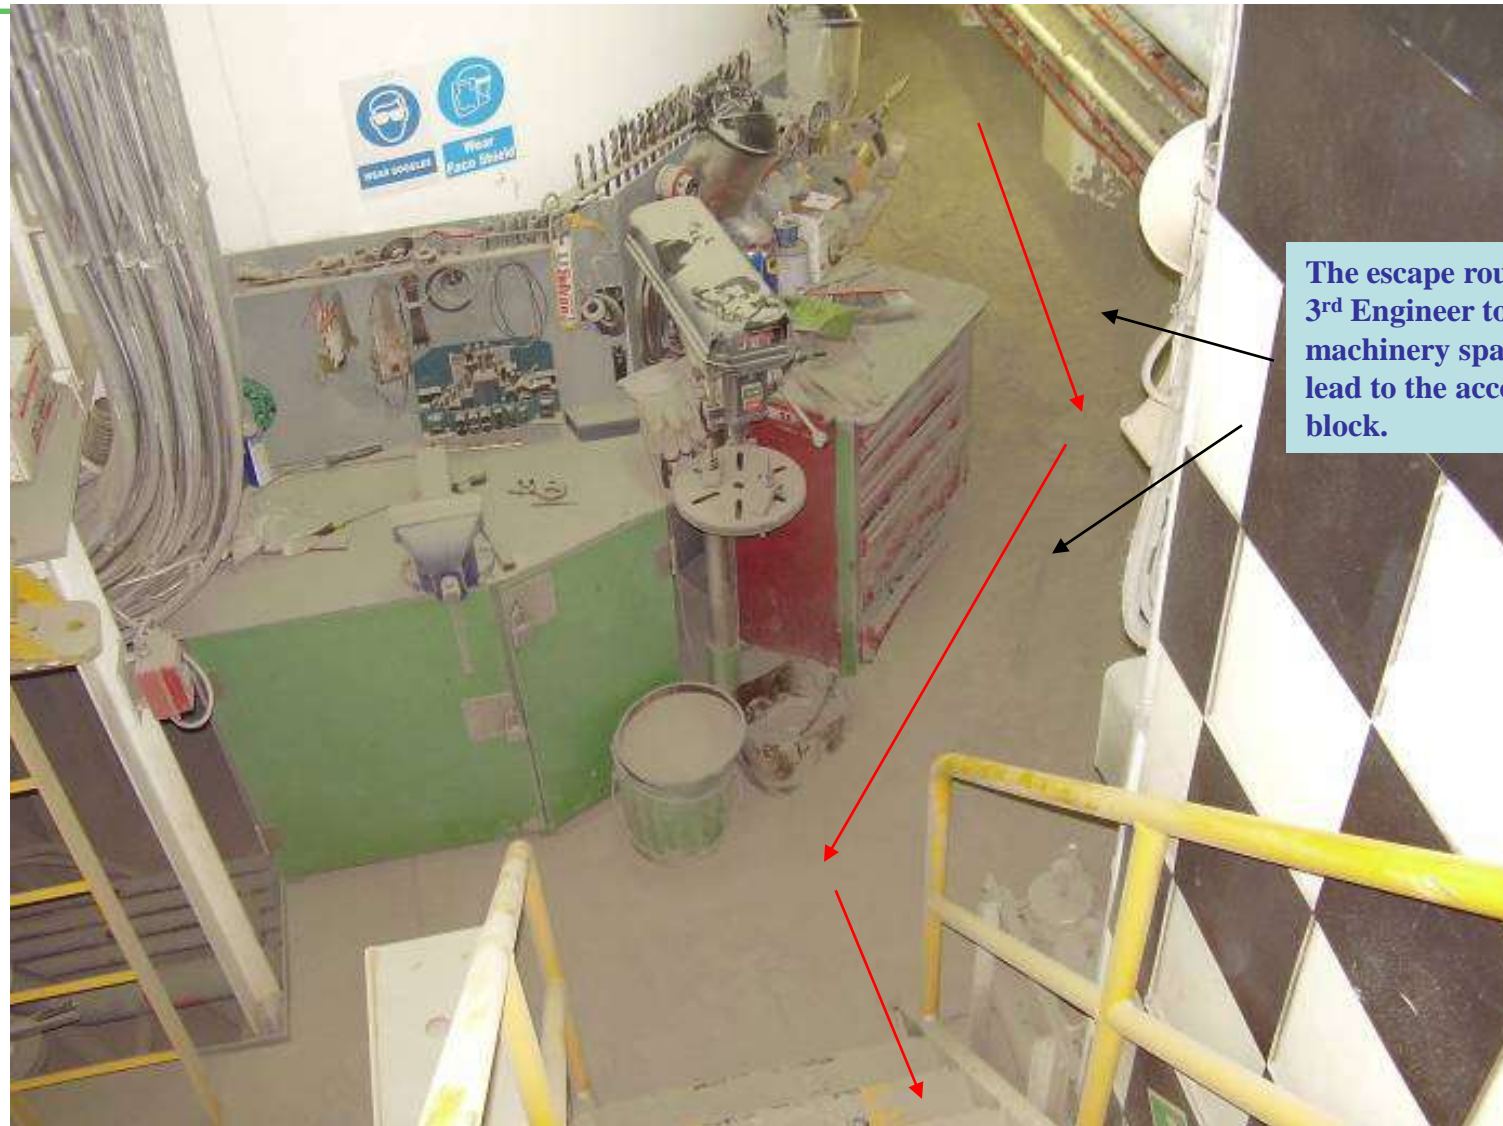
The escape route used by the 3<sup>rd</sup> Engineer to exit the machinery space. The stairs lead to the accommodation block.
