MAERSK OIL QATAR AS DRILLING DEPARTMENT SAFETY STATISTICS 2009 and Q1- Q3 2010

DOIRC Meeting Q4 2010

SAFETY ALERT

Rowan Paris – CD Production Platform Falling Object from top deck of CD platform

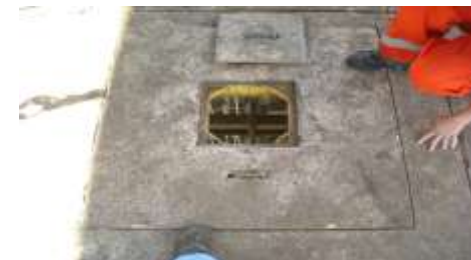
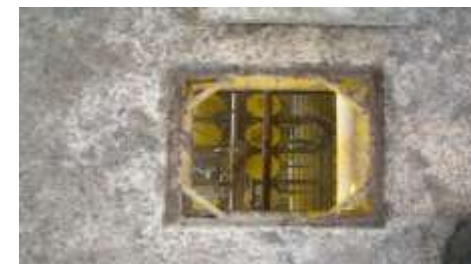
A +200 lbs 42" x 42" slot cover on the CD Platform flipped over and fell into it's own hole when trying to install it. The 42" x 42" cover was stopped by a scaffolding pole routed across the slot opening 4.7 ft below the top deck but the smaller integrated 13" x 13" cover weighing +/- 20 lbs fell out and continued falling 37 ft down where it landed 1-2 m from a person on the mezzanine deck.

- It was not realized in this routine operation that with this particular platform design this can actually happen.
- The work permit did not cover this particular operation and the risks associated. Barriers were not in place.
- Cover was attempted installed by hand instead of an air winch.

- Severe injury to personnel or in worst case fatality.
- Damage to X-mas trees, lines and gauges with possible hydro-carbon release as a result.

- Handling of hatch covers only to be done through the PTW system.
- A supervisor to be present and correct lifting technique applied with all barriers in place.
- Changing the design of the hatch covers will be pursued.
- Focus & training in the PTW system, Conducting Safe Job Analysis, Correct Supervision and the importance of following procedures to be strengthened.

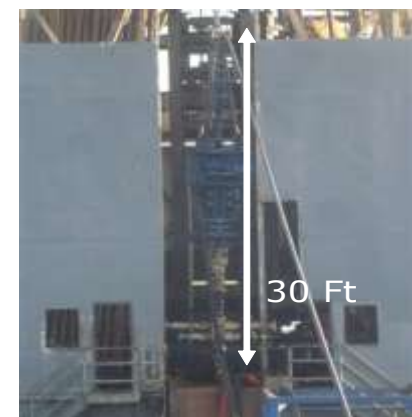
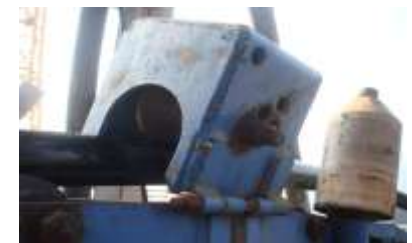
While pulling out of hole, the tubing reel stopped moving momentarily. This caused the tubing, which was being pushed out of hole by the injector, to lift up and push against the gooseneck roller cover rather than being pulled on to the reel. The force of the tubing being pushed against the roller cover caused the pin on the cover to shear and the roller cover (7Kg) to fall approximately 30 ft to the rig floor.

- Mechanical failure caused the reel to stop moving.
- The failed pin (bolt) was 'home made' of several sections of threaded rod welded together. (Subsequent inspection of the remaining pins suggested they were original.)

- Severe injury to personnel or in worst case fatality. (Although area below gooseneck had been barriered off and no personnel were in the vicinity of where the roller cover had landed.)

- Training of service provider maintenance personnel by equipment manufacturer.
- Improve equipment preventative maintenance program.
- More thorough load-out inspections to ensure equipment sent out is in safe working condition.
