# **“Sheave Uncontrolled Descent Onto The Rig Floor.”**

## **HIPO Near-Miss Incident**

**HSE Incident Number – RHS # 537980**

# HCT – SHEAVE GOOSE NECK NEAR MISS INCIDENT

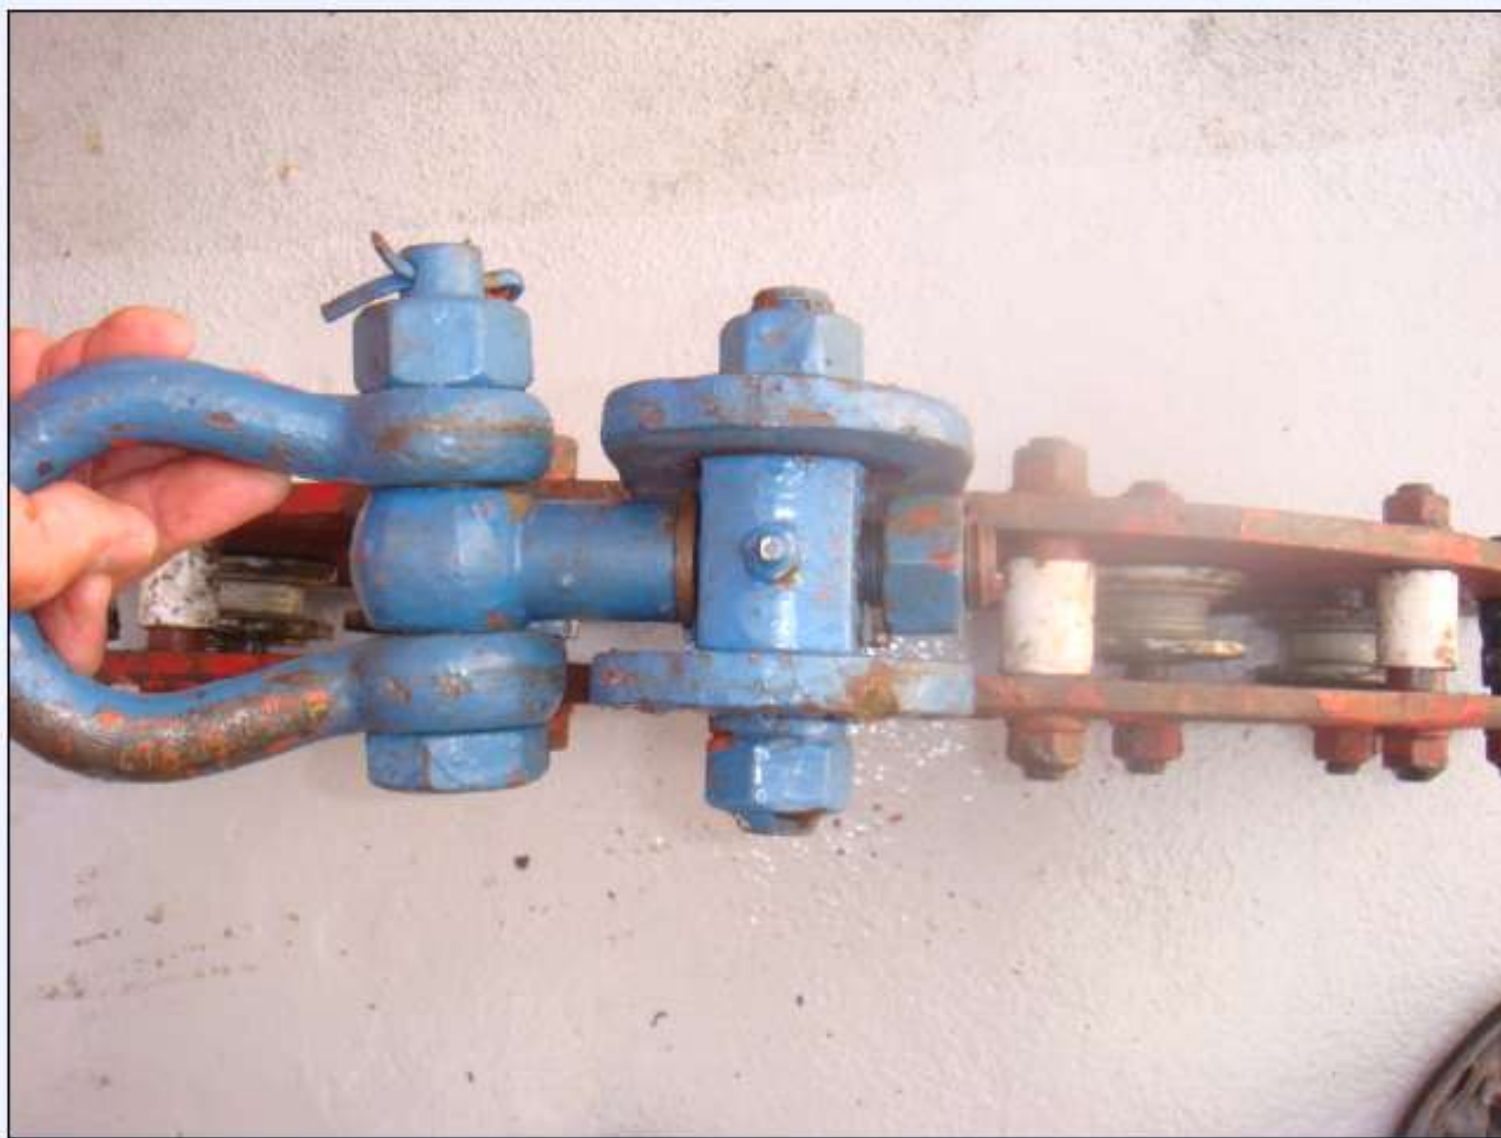
# SHEAVE GOOSE NECK

- This was due to the sheave’s eyebolt-retaining nut backing off, allowing the sheave that weighed 48Lbs (22kg) to descend onto the rig floor.
- The sheave was suspended from the rig floor hydraulic hoist at a height of 12’ (4M) above the rig floor.

- The investigation reveals that the secondary retaining device (split washer) was inadequate to hold the nut from backing off.
  - The split washer was not recovered during the investigation but eye witness testimony confirms the presence of the lock washer during rig up.

Inadequate secondary retention for nut.

Comments:    During the investigation, it can not be established that in the fabrication of the sheave goose neck has a proper engineering drawing/design that meets International and/or Halliburton standards. No engineering designs were found. □

Comments:    The sheave goose neck in question was fabricated in a local company in Qatar in 2005 and was inspected/certified by a reputable inspection company (BV) and found fit for use. Furthermore, it has undergone series of visual inspection both from Halliburton and the customer contracted QA/QC representative but the inadequacy of the nut retainer was not picked up as a hazard that may have resulted for the sheave goose neck to fail.

- Raised awareness to personnel on local locations.
- Inspected similar equipment at other work locations and ensured that appropriate locking cutter pin are installed.
- Quarantined other Sheave goose necks in the yard.

Causal Factor	Root Cause	Corrective Action	Completion Date	Responsibility
<b>Causal Factor – Inadequate secondary Retention for nut.</b>	Equipment Difficulty (1E) Design (2D) Design Specifications (3S) <b>Specifications NI (4SP)</b>	1.0 Quarantine and remove from service all locally fabricated equipment without the verified certification.	15/03/2010	HCT Shawn Almstrong
	Equipment Difficulty (1E) Design (2D) Design Specifications (3S) <b>Specifications NI (4SP)</b>	2.0 Verify process of fabricating) equipment locally.	15/03/2010	Halliburton QA/QC Roland Quiroz/Aldin
	Equipment Difficulty (1E) Design (2D) Design Specifications (3S) <b>Specifications NI (4SP)</b>	3.0 Replace locally fabricated equipment with Company/PSL approved design for operational requirement.	30/06/2010	HCT/PML Scott Cooper
	Equipment Difficulty (1E) Design (2D) Design Specifications (3S) <b>Specifications NI (4SP)</b>	4.0 Review the third party inspection process and ensure that it aligns to HSE/PSL and customer requirements.	15/03/2010	Halliburton QA/QC & HSE Roland Quiroz/ Aldin Isurita, Dan Baquilod

Equipment Difficulty (1E) Design (2D) Design Review (3R) Independent Review NI <b>Hazard analysis NI (5HA)</b>	5.0 Review and as needed, revise existing JSA and/or Risk Assessment to include specific load bearing equipment (e.g. Sheave goose neck, lifting clamps, spooling devices, etc.).	22/03/2010	HCT Shawn Almstrong
	Equipment Difficulty (1E) Design (2D) Design Review (3R) Independent Review NI <b>Hazard analysis NI (5HA)</b>	6.0 Ensure that the installation of secondary retention device for sheave goose neck and similar devices are captured in the JSA and implemented/practices at all times.	22/03/2010	HCT Shawn Almstrong
	Equipment Difficulty (1E) Design (2D) Design Review (3R) Independent Review NI <b>Hazard analysis NI (5HA)</b>	7.0 Distribute and confirm understanding of Shell's EP 2009-9039 Prevention of Dropped Objects Manual across PSL's in Northern Gulf (Qatar & Kuwait). Manual to be made available to all Product Service Lines (PSL).	30/04/2010	PII H&S Teams ( NG-Qatar/Kuwait) Scott Cooper/Chris Barnes and Dan Baquilod (HSE)

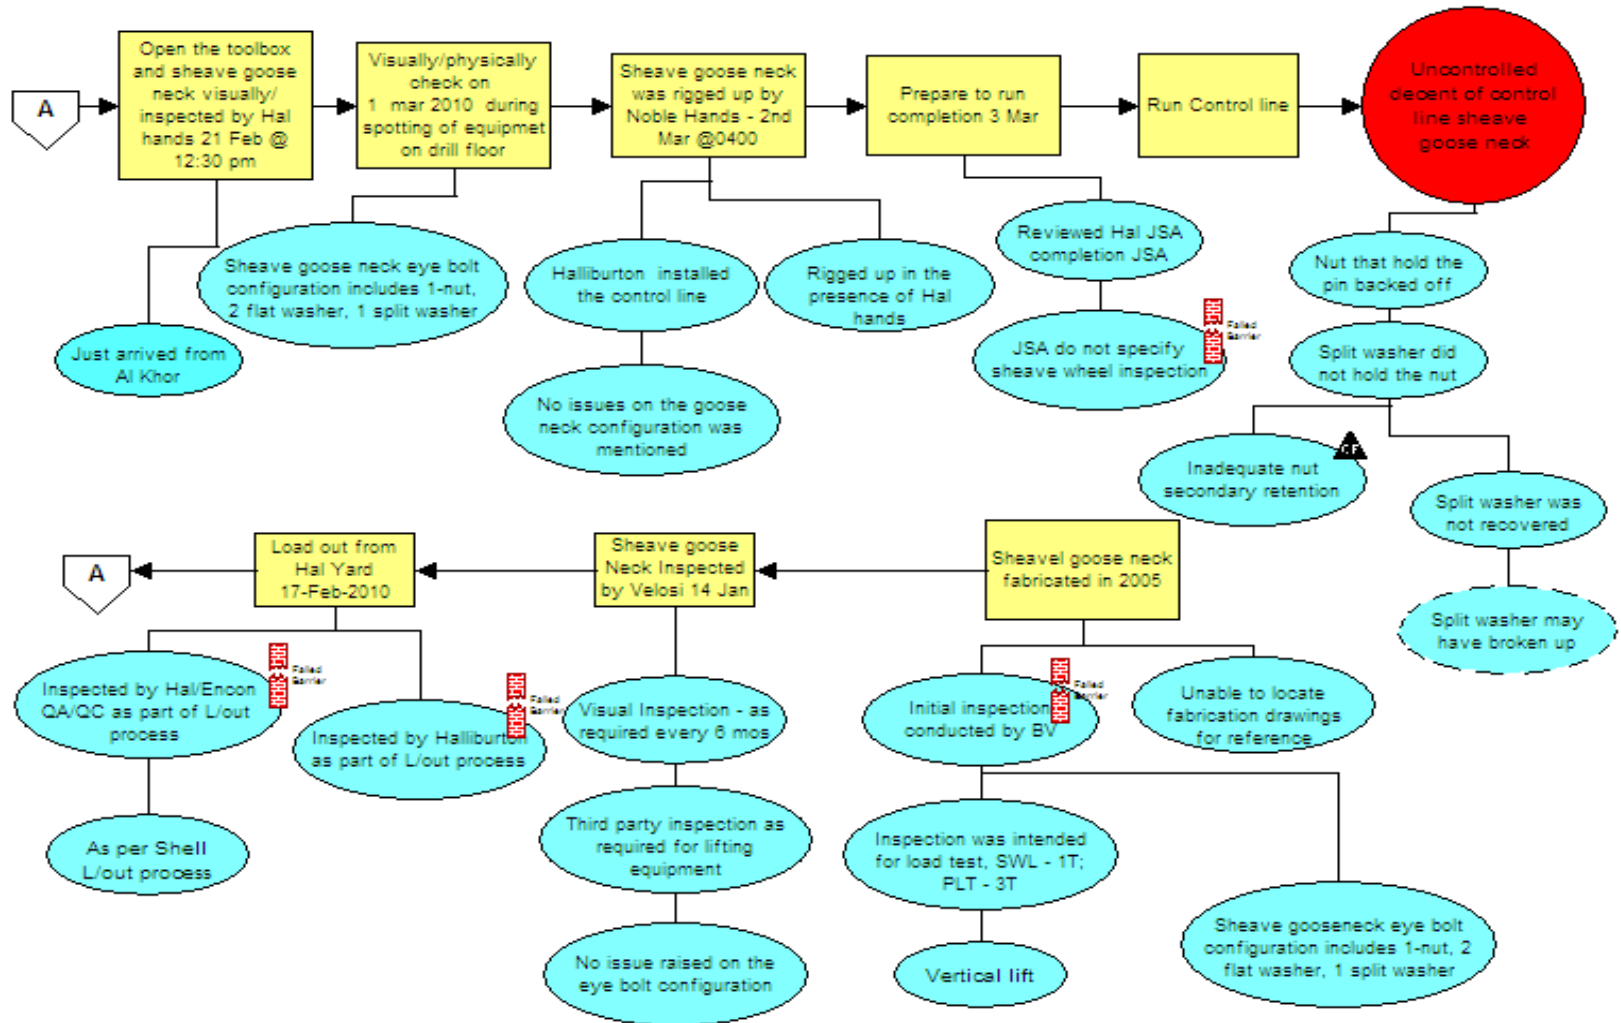
- On 3rd March 2010, at about 16:30 hours while RIH with the 7” completion, the Halliburton TRSSSV (Safety Valve) control line sheave descended, uncontrolled, onto the rig floor.
