# RasGas Sub Surface Safety Stats Q4 2010 & Q1 2011

# Near Miss – Ensco 94

## 9<sup>th</sup> Dec 2010

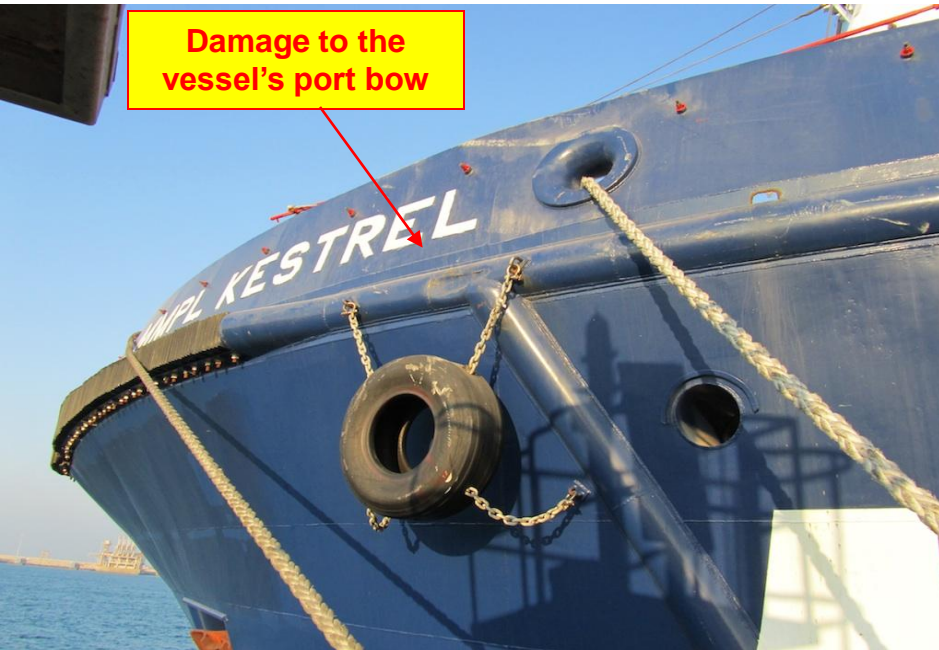
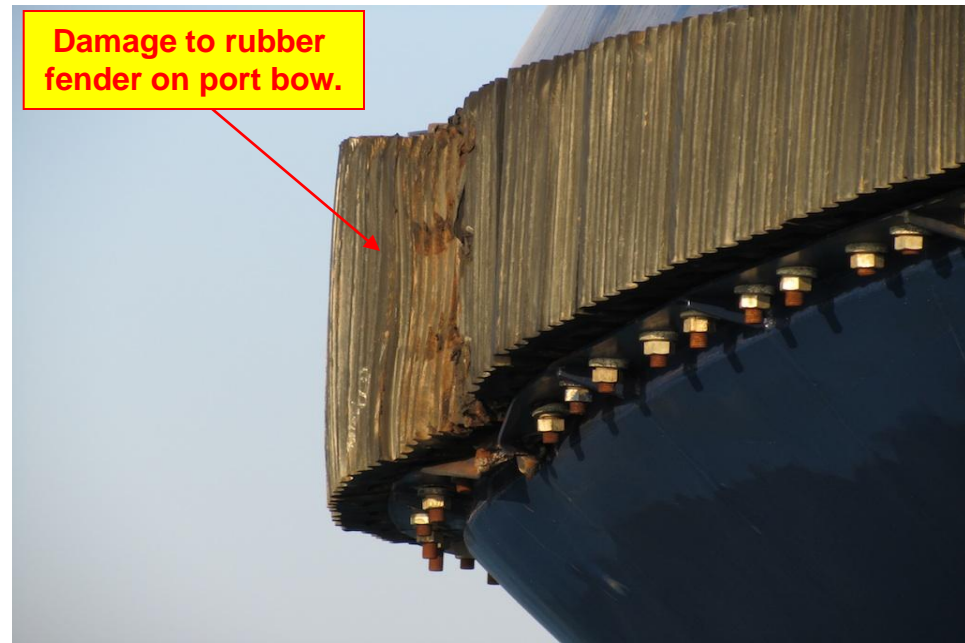
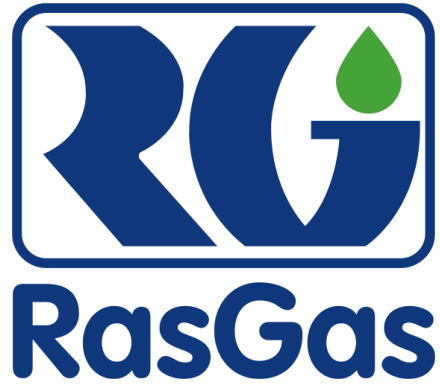
# Photos and Illustrations

- The MMPL Kestrel departed Ras Laffan for a cargo run to Ensco 94
- Ensco 94 was contacted for permission to enter the 500m zone & was granted after completion of RG arrival checklists
- The Senior Dynamic Positioning Officer 1 (SDPO 1) positioned the vessel between the rig & mooring buoy at between 150-200m from the rig & started to rotate the vessel
- The rotational swing of the bow, resulted in the port bow of the vessel making contact with the Ensco 94

- The vessels movement should have been arrested before DP mode was selected
- Speed was found to be excessive to be travelling at when entering & within the 500m zone, where the vessel is subsequently at close quarters to a structure
- Taking of this shortcut had become normal behavior due to a desire to please the client & have the vessel able to work the rig quicker
- Whilst the weather was not severe & under normal conditions would not be a problem, with any failure, the environmental factors push the vessel towards instead of away from the rig

- Review practice of bringing vessels in on weather side, so far as is possible to bring vessels to the non-weather side
- All vessels will be instructed to maintain 'steerage way' speed only inside 500m zone. This is the minimum speed with which they can maintain safe steerage
- SDPO 1 to be replaced. Crewing recruitment procedure to be reviewed to select candidates with more vessel handling experience
