# GDI-4

## TRAVELLING BLOCK HOOK INCIDENT

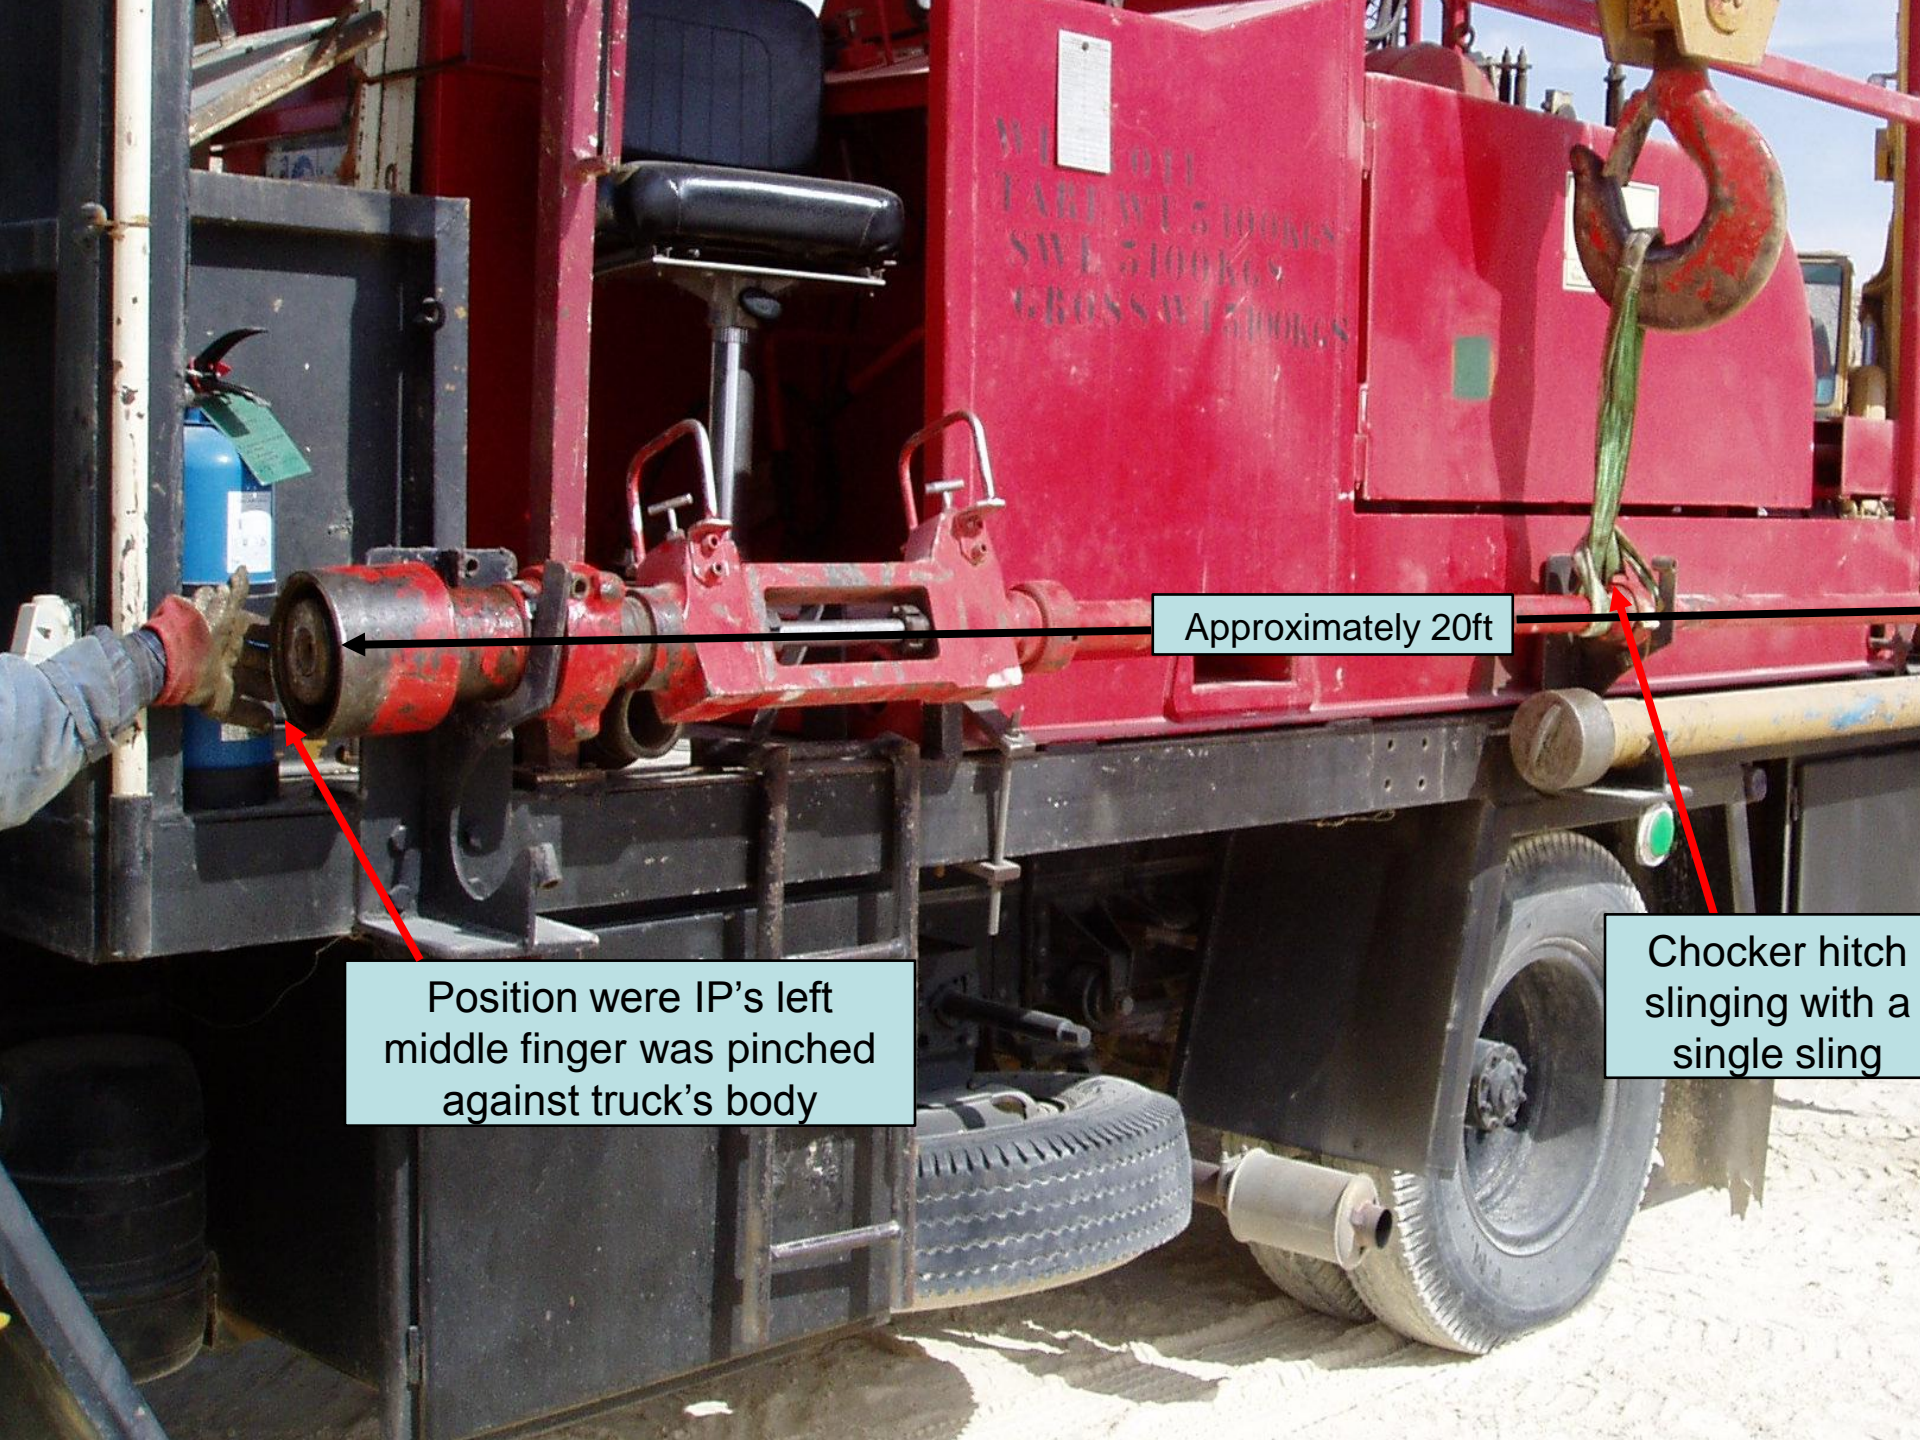
- Wireline crew were removing pressure lubricator of about 20ft length and approximately 500kg from the wireline truck with GDI crane.
- Wireline crew decided to sling the pressure lubricator at the middle with a lifting single sling by chocker hitch.
- Crane operator was in a blind spot to load as the crane was positioned at the other side of the wireline truck.
- Injured party was controlling load with his left hand at one end instead of using a tag line.
- As the load was lifted off the brackets, IP attempted to prevent it from swinging and in the process his left middle finger was pinched against the truck's body as result of which he suffered superficial amputation.

Approximately 20ft

Position were IP's left middle finger was pinched against truck's body

Chocker hitch slinging with a single sling

- Train and certify crews on Safe Rigging/ Slings operations.
- Review / revise Lifting procedures and Job Safety Analysis to address use of tag lines and safe slinging.
- QP and all SOS crews had a workshop with practical demonstrations on safe slinging and lifting operations with emphasis on the same tool.
- All simultaneous operations shall be discussed, risk assessed and approved by key personnel on the rig prior to commencement.
