Noble Corporation

Noble David Tinsley

**Medical Treatment Case
01-Feb-2009**

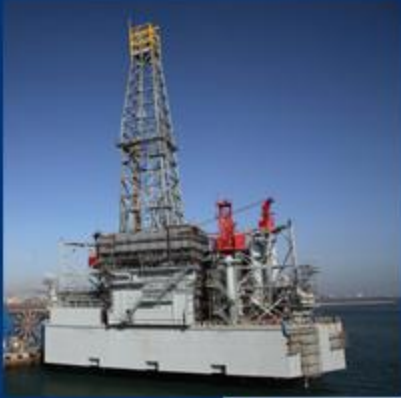
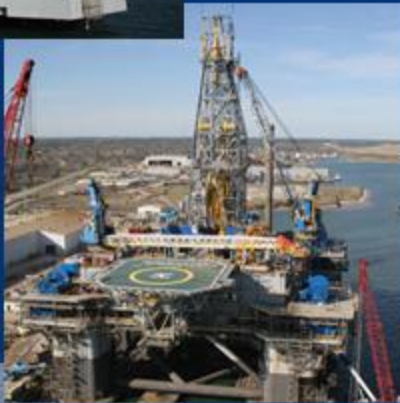
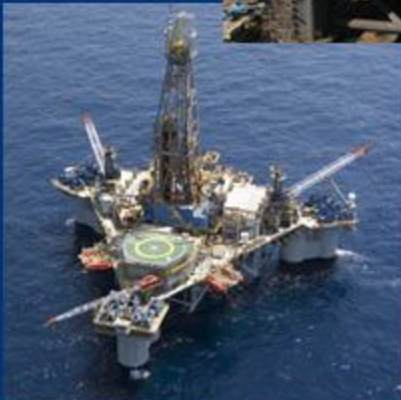
While tightening the last nut with a torque multiplier wrench, the Injured Person believed he had to change position in order to obtain the proper leverage to obtain the required torque. He did so while the torque multiplier was still under tension.

The stored energy in the torque multiplier was now directed towards the IP rather than away from him. His hand slipped from the wrench and resulted in the release of stored energy. The wrench handle struck his left temple approximately 2 cm from his left ear, causing a small but deep cut.

- 1- Failure to communicate – the hazard of unsafe body positioning and the proposed corrective action of erecting a work platform was not communicated to the oncoming crew.**
- 2- Failure to perform a pre-job inspection to determine additional hazards. Supervisory and crew member perception was that we always did it that way. This was an accepted rig practice.**
- 3- Improper body position for the task at hand due to lack of proper working platform.**

- 1- When stopping a job for an unsafe condition that cannot be immediately be corrected, the Rig Manager will be notified immediately. The area will be protected with a barrier and signs will be placed stating “No work will proceed in this area until approved by the Rig Manager”. Communicate this to all crew members.
- 2- A pre-job hazard hunt shall be conducted for all jobs.
- 3- Develop a pre-job hazard hunt checklist, that includes the potential release of 8 forms of energy.
- 4- Revise JSA's for each job required to include step number 1 on the JSA being "Conduct a pre-job hazard hunt."

- 5- Continue to deliver training programs that improve safety behaviors, both at the Division level and through the corporate Leadership & Development Department.
- We must alter the perceptions of people that conscious risk taking is ok.
- Until we change this perception, which drives unsafe actions, we cannot expect to Get To Zero, and live in a World Where Nobody Gets Hurt.
