TapRoot Investigation

**Deck Personnel Attempting to Relocate 55
Gallon Drums Resulting in Finger Injuries**

Halul 15

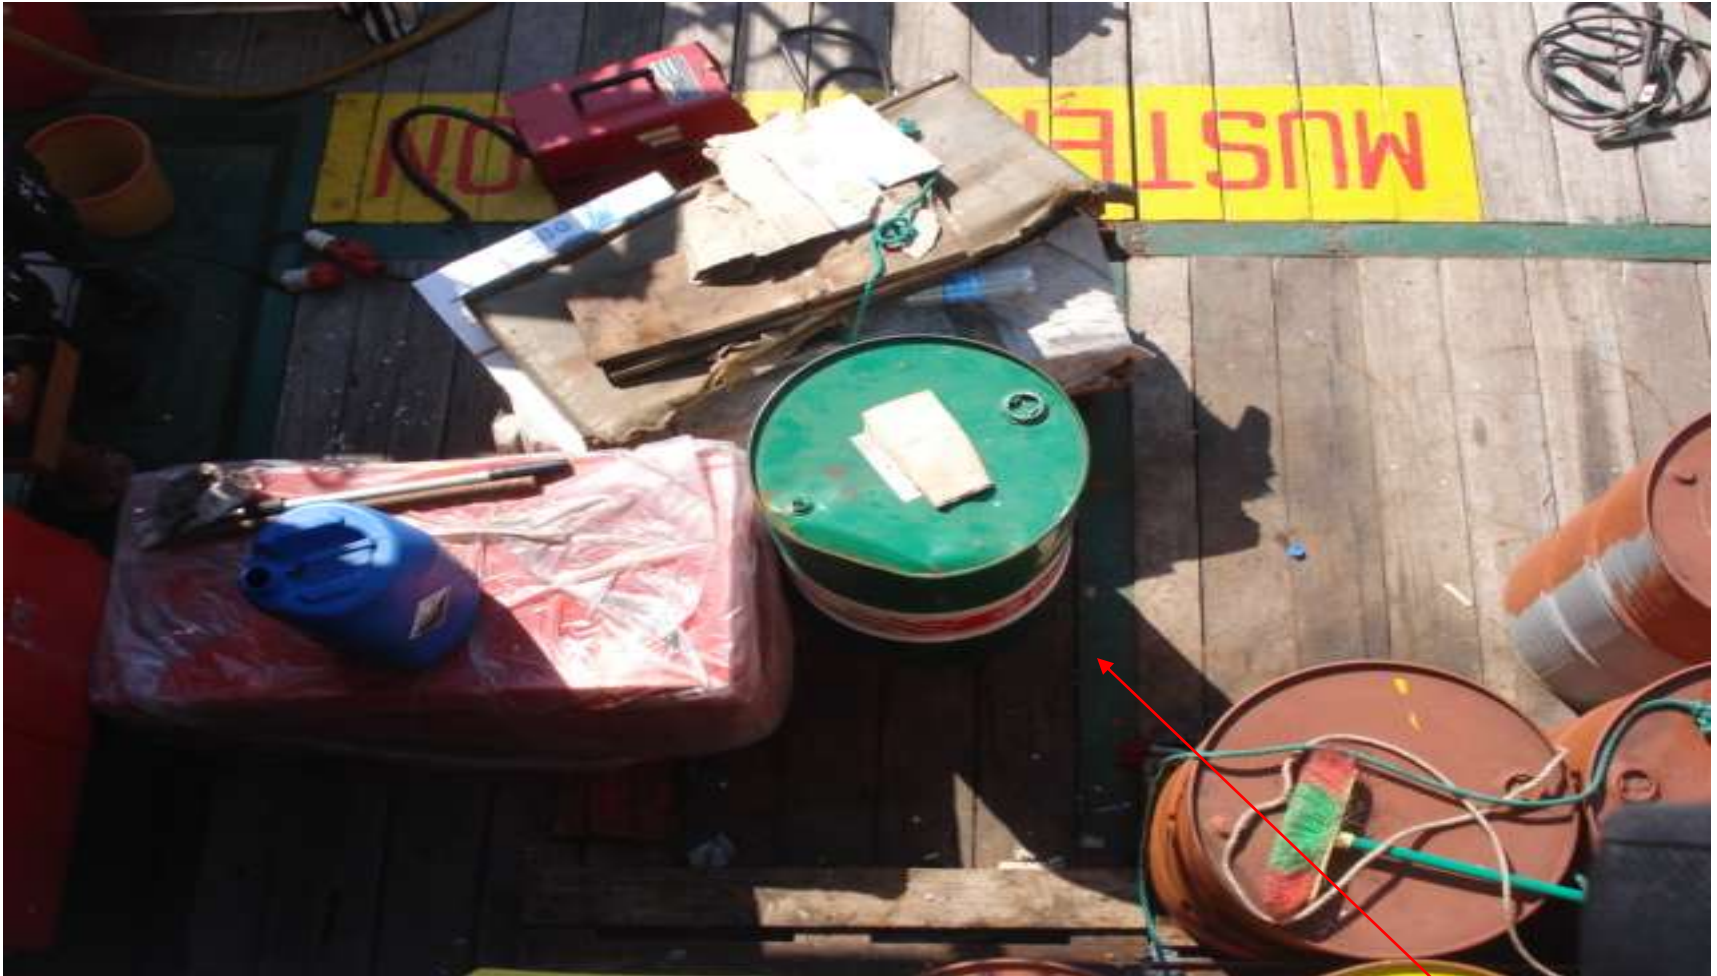
The incident site as viewed from above. The green drum was being moved around 2m and became partially lodged here enroute to the pallet visible at the bottom of the picture. Poor work planning is evident from the other items around the drum causing congestion.

Root Cause	Corrective Action	Due Date	Responsibility
<p><u>Work Direction</u> Preparation</p>	<p>Vessel Master, deck supervisor, jetty foreman to conduct more effective discussions and implementation of loading plans. All equipment requiring access must be unimpeded.</p>	<p>Immediate</p>	<p>RasGas Marine / Halul Offshore</p>
<p><u>Management System</u> • SPAC NI</p>	<p>Crew members must be aware that short cuts are not acceptable and all jobs must be given the sufficient time to be completed safely. Deck Supervisor to ensure compliance and accountability.</p>	<p>10th Jan 2010</p>	<p>Halul Offshore</p>
<p><u>Work Direction</u> Preparation</p>	<p>A Tool Box Talks must proceed all tasks and be attended by all personnel involved in the tasks. In the event of a change in conditions, personnel or scope of work, the job should be stopped and a new Tool Box Talk held.</p>	<p>10th January 2010</p>	<p>Halul Offshore</p>

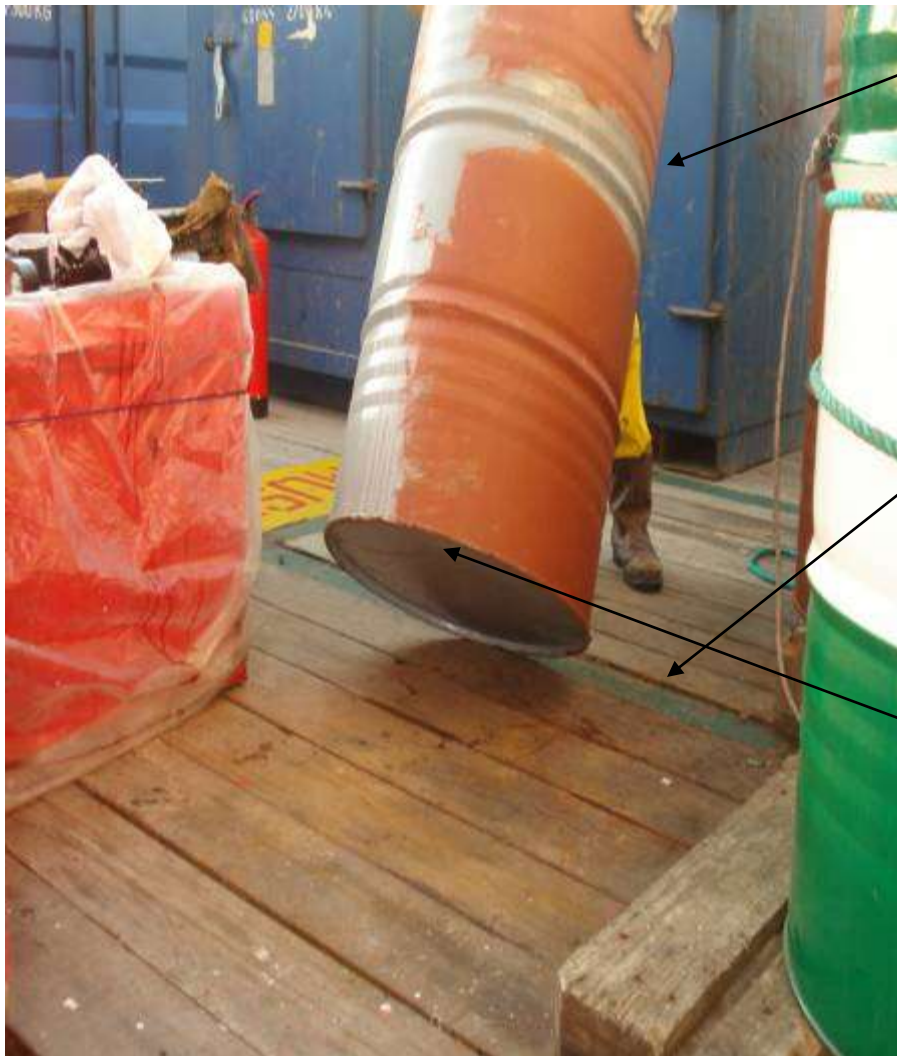
The method used to move the drum across deck. The full 55Gallon drums weighs 200kg.

Uneven deck surface where the third drum became partially lodged. A trolley could move over the differences in the deck.

IP crouched down and put his hands and fingers under the drum to pull it towards himself and dislodge.

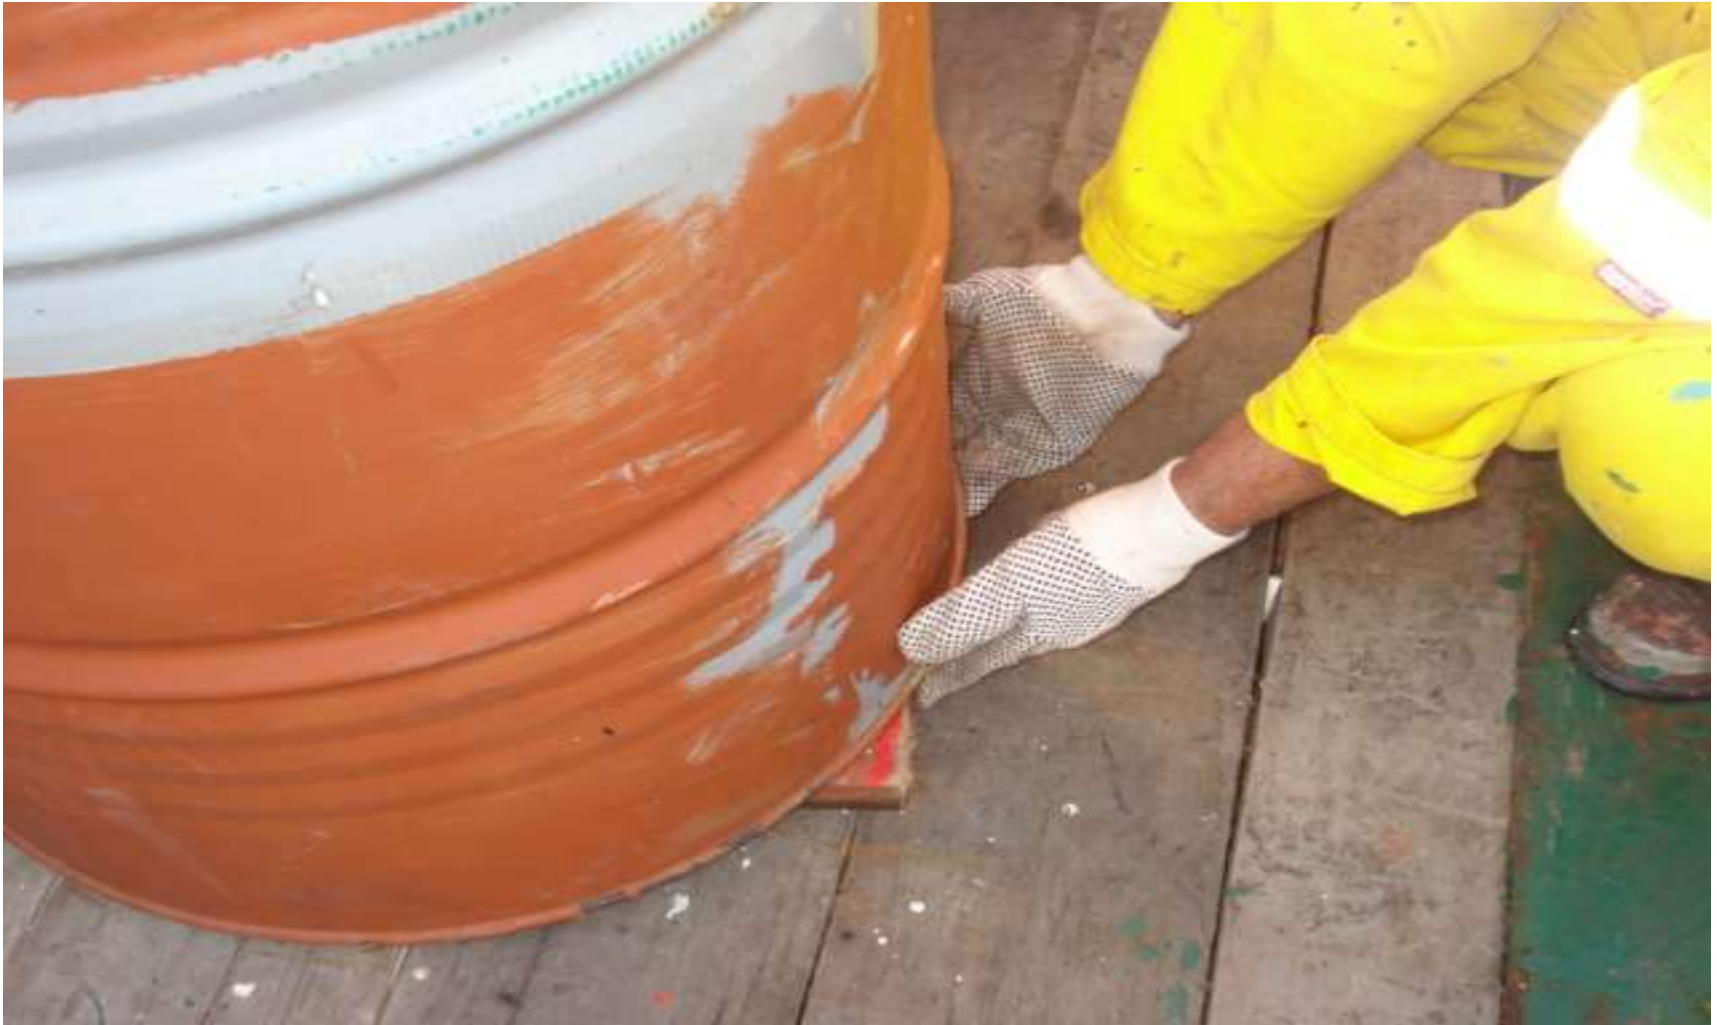
A re-enactment of the incident. When the edge of the drum became partially lodged the IP put his hands under the drum and pulled it towards himself.
